**Demolition of Structures Located at  
Storage Structure on 2<sup>nd</sup> Street, Yucaipa  
12806 2<sup>nd</sup> Street, Yucaipa,  
12816 2<sup>nd</sup> Street, Yucaipa  
12834 2<sup>nd</sup> Street, Yucaipa**

Proposal No. 210331

Issued on March 31, 2021

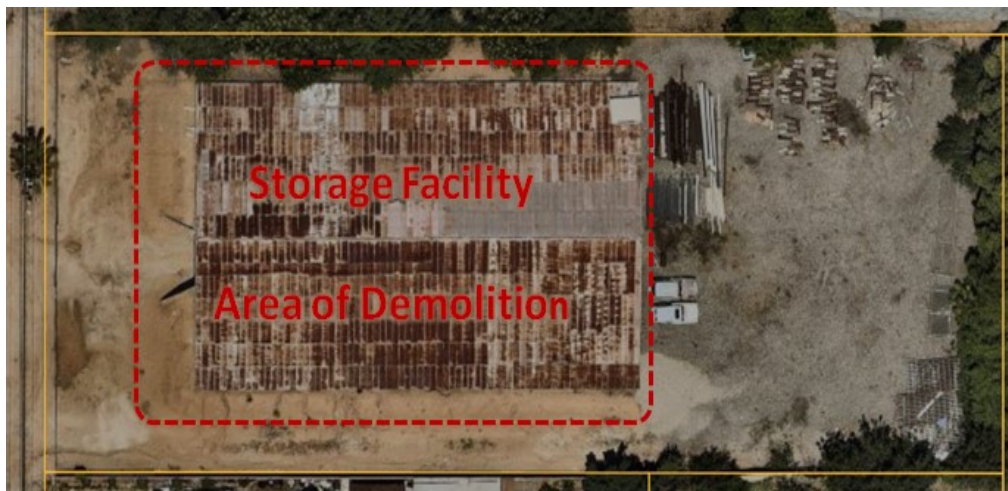
Storage Facility - Imported fill material may be needed at the Storage Facility Site to avoid ponding after the demolition has been completed. The fill material shall be select soil material, non-expansive with an expansion index of less than 20, free of vegetative matter and other deleterious substances, granular with a Sand Equivalent (SE) greater than 30 and shall not contain rocks or other irreducible matter with a maximum dimension greater than 4". Fill material shall be approved by the Owner prior to use onsite and may be available from the other properties identified below.

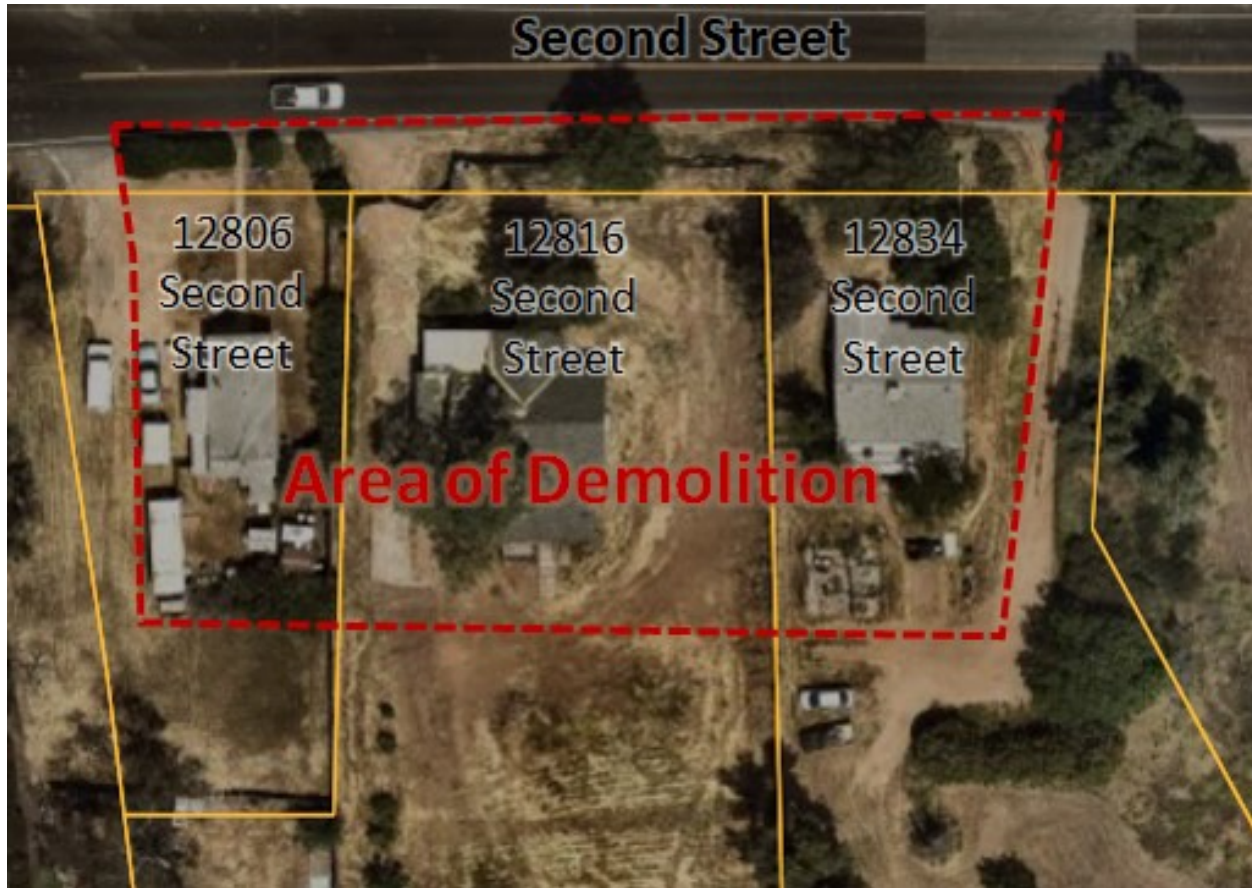
Three Residential Structures - The Yucaipa Valley Water District ("District") owns three adjoining parcels: 12806 2<sup>nd</sup> Street (APN 0319-121-38), 12816 2<sup>nd</sup> Street (APN 0319-121-39), and 12834 2<sup>nd</sup> Street (APN 0319-121-63), Yucaipa. On these properties the demolition will involve the demolition and removal of all above ground house structures, concrete foundations, trees, bushes, fences, walls, and below ground utility services lines within the area delineated below.

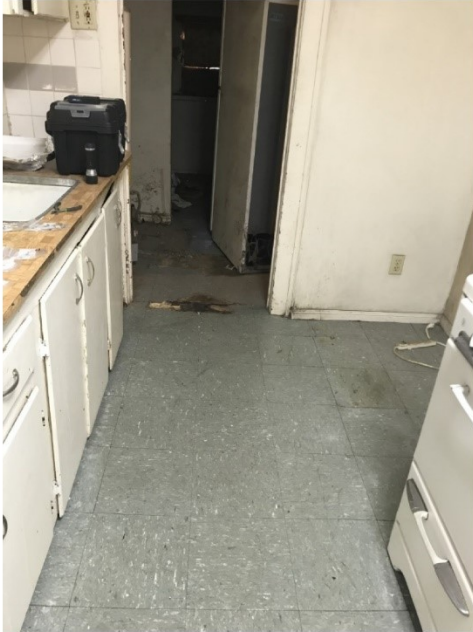
Picture 1: Scope of kitchen flooring

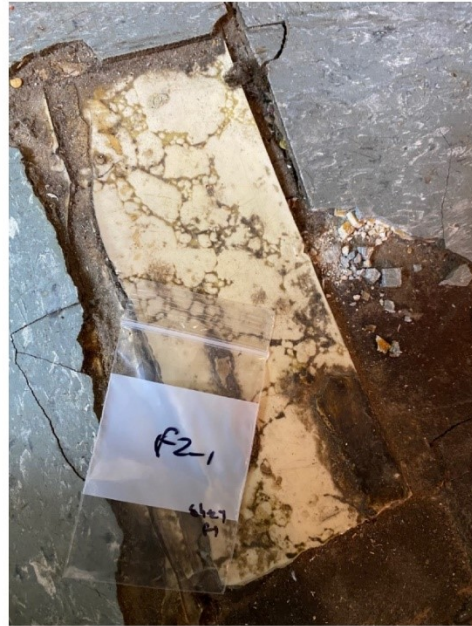
Picture 2: Asbestos-containing sheet flooring

**Abatement by a licensed abatement contractor is recommended prior to disturbance of asbestos-containing materials.**

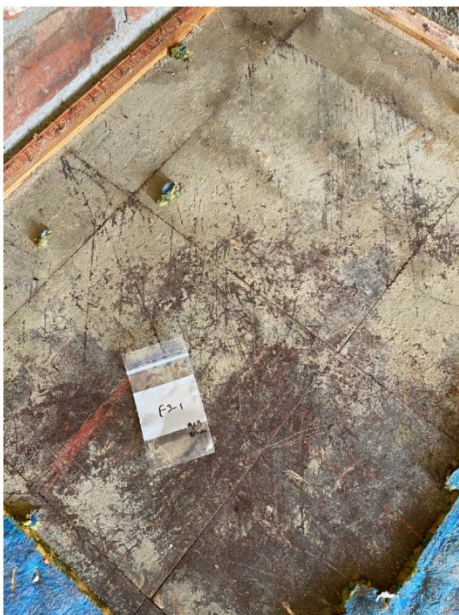
Picture 3: Asbestos-containing brown 9x9 floor tile

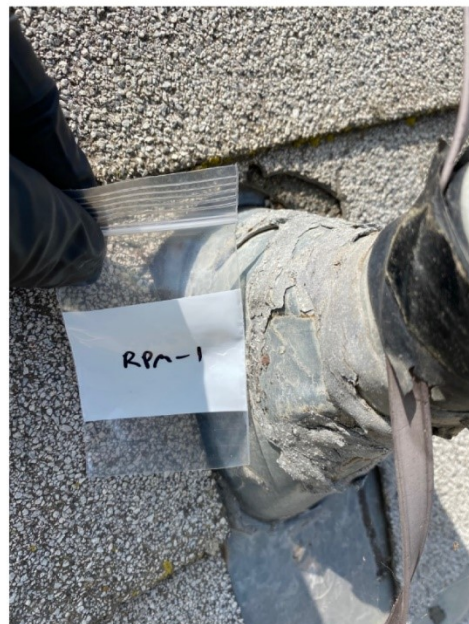
Picture 3: Asbestos-containing roofing penetration mastic around the ducts

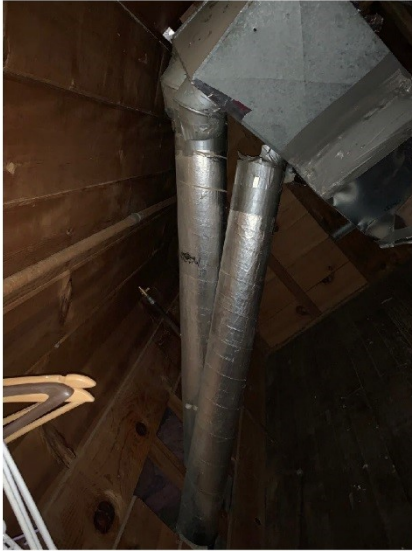
Picture 1: HVAC Duct wrapping in the attic was found to be ACM

Abatement by a licensed abatement contractor is required prior to disturbance of asbestos-containing materials. It is always necessary to comply with the pertinent provisions of EPA, OSHA and AQMD regulations during any removal or repair activities that may disturb the asbestos- containing materials that may have been inaccessible and or untested during the survey. Not all areas of the home were tested, only impacted areas. Caution should be taken when inaccessible and untested areas are disturbed.

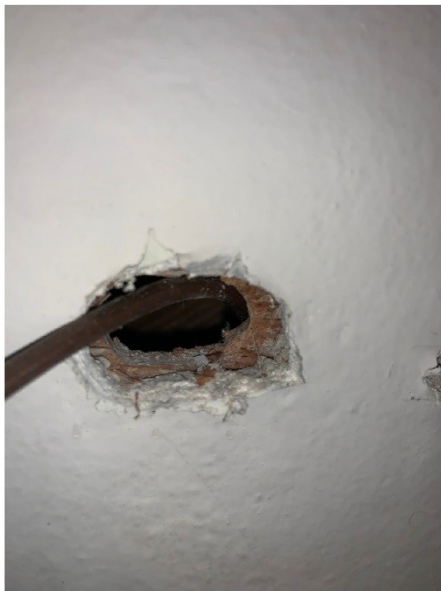
Picture 3: Wall system sampled was found to not contain asbestos

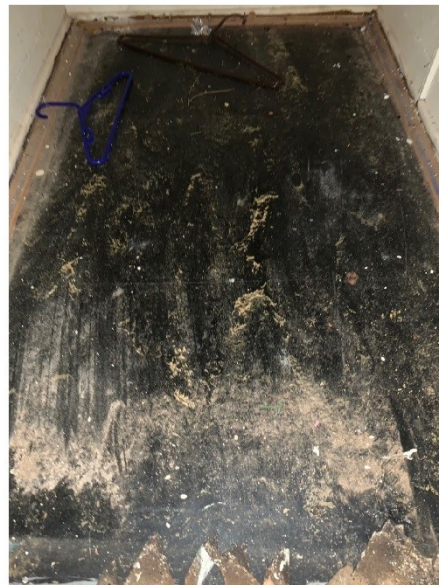
Picture 4: Black flooring sampled in closet was found to not contain asbestos

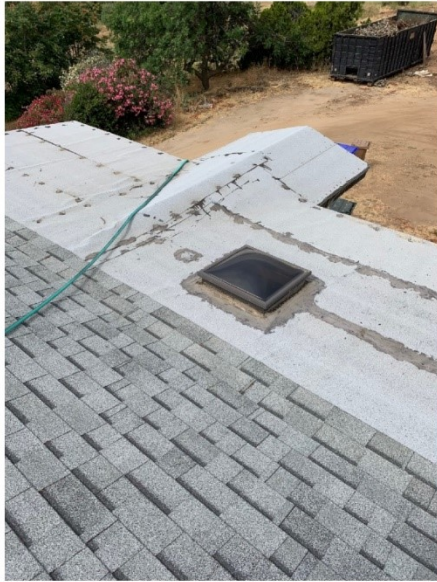
Picture 1: Roofing of the subject property was found to not contain asbestos

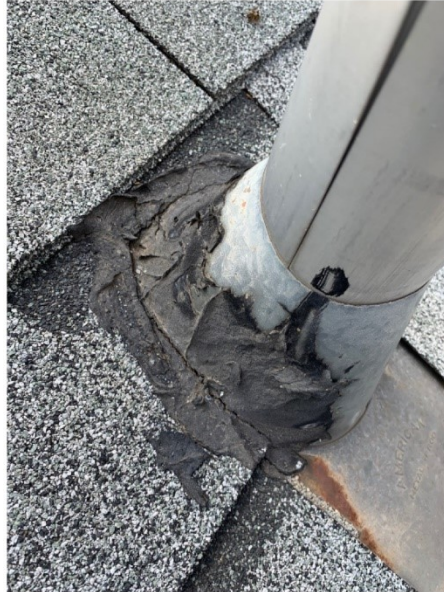
Picture 2: Penetration mastic sampled from the roof

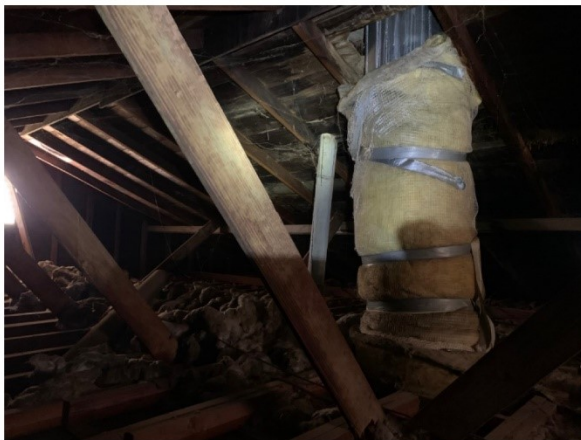
Picture 3: Thermal system insulation around the boiler duct was found to be ACM

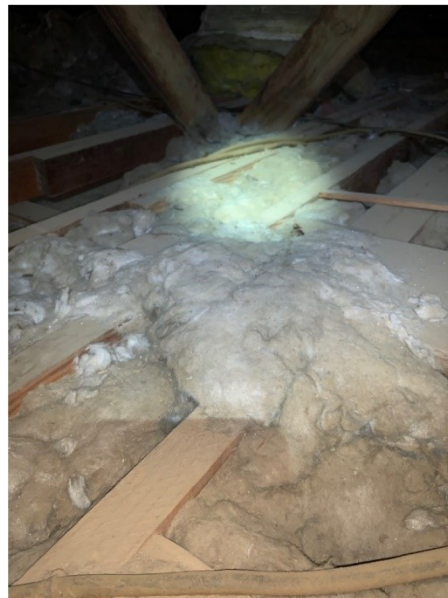
Picture 4: Insulation was found to not contain asbestos

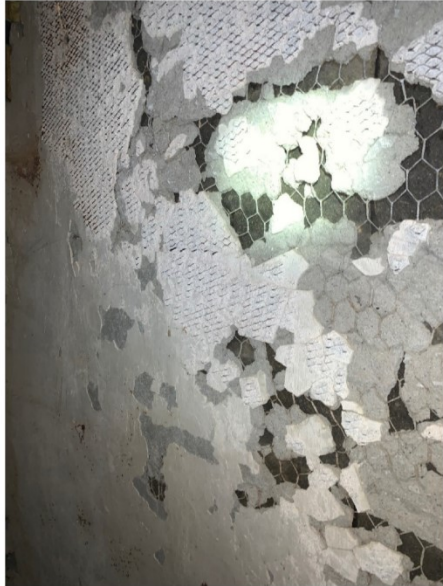
Picture 5: Exterior stucco was found to not contain asbestos

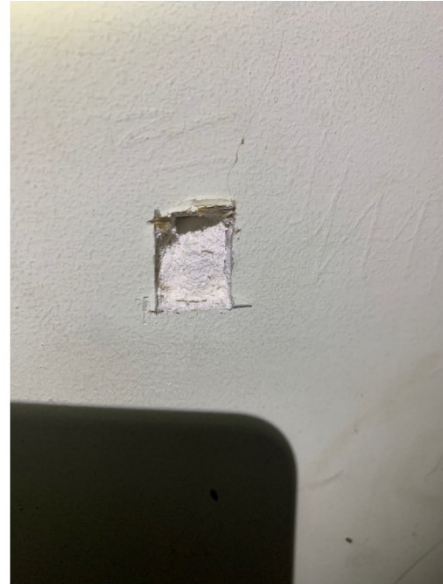
Picture 6: Wall system was found to not contain asbestos

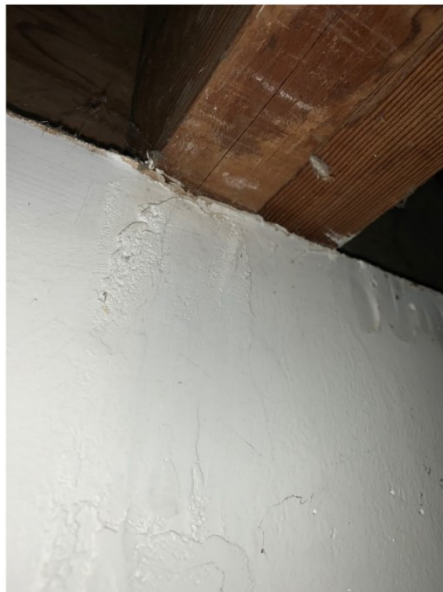
Picture 7: Joint compound was found to not contain asbestos

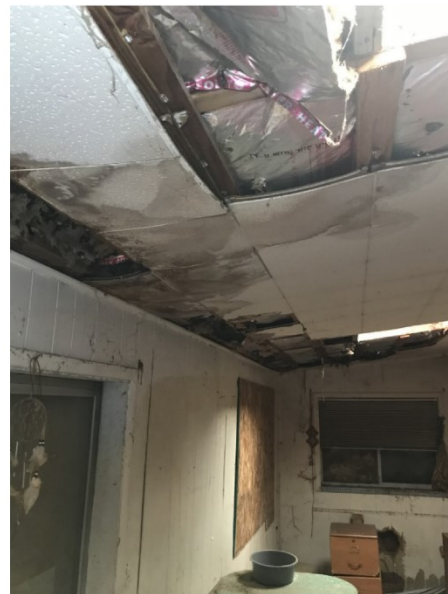
Picture 8: Damaged ceiling tile was found to not contain asbestos

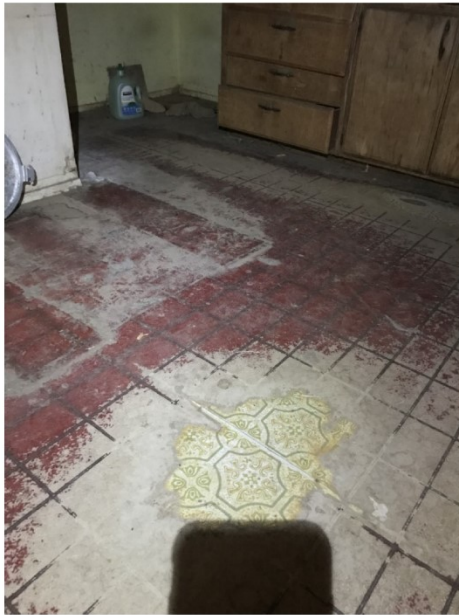
Picture 9: Layered sheet flooring sampled from the kitchen was found to be ACM

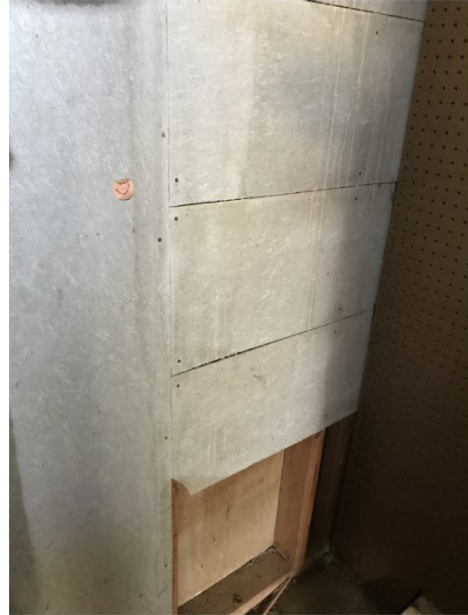
Picture 10: Particle board sampled was found to be ACM

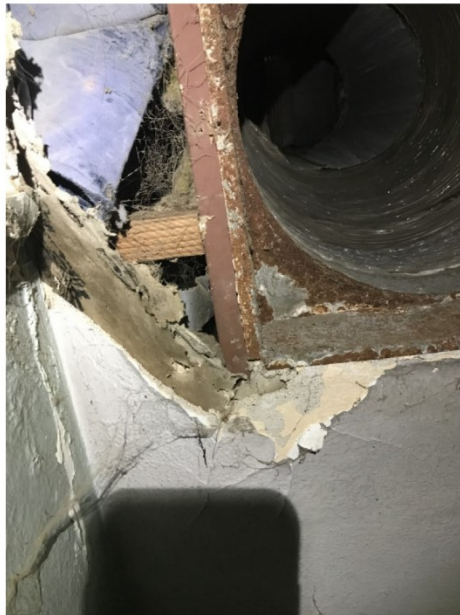
Picture 11: Plaster sampled was found to not contain asbestos
